# Healy Community Wildfire Protection Plan 2024

## Appendix A - Community Ignitability Analysis

# Healy CWPP Appendix A

## COMMUNITY IGNITABILITY ANALYSIS

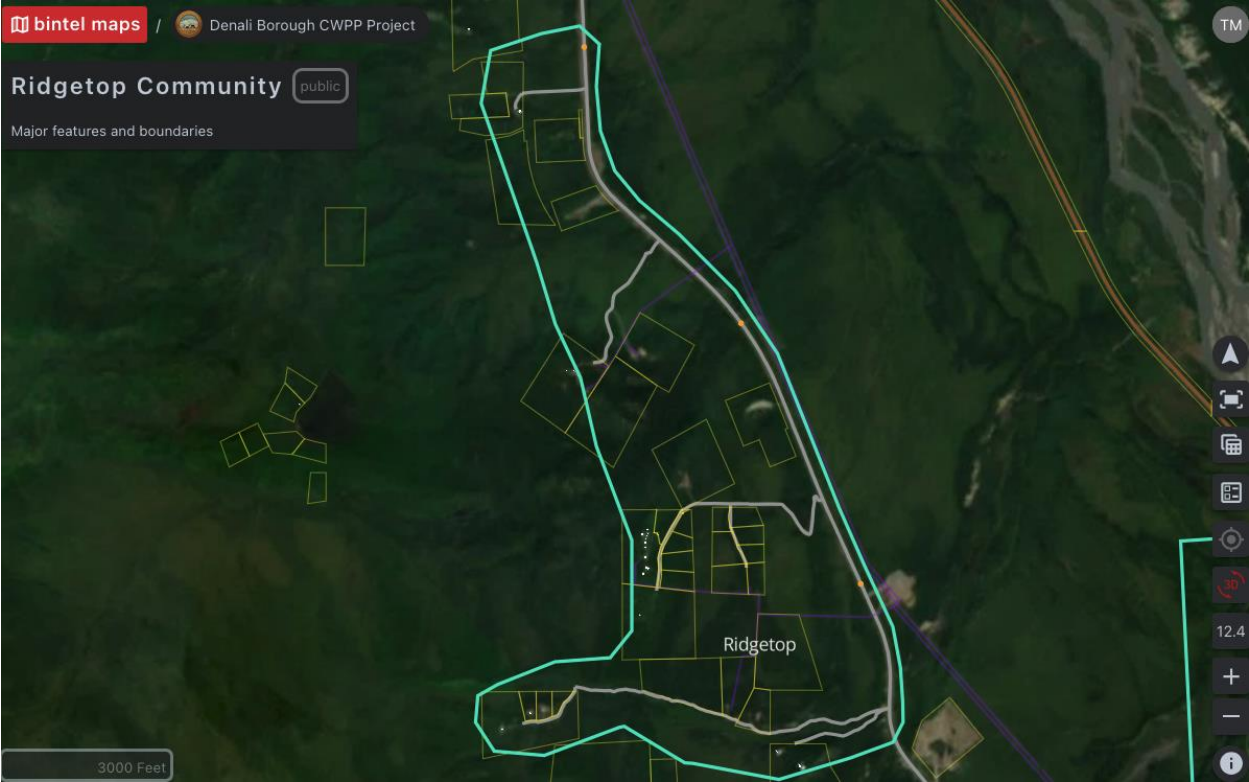
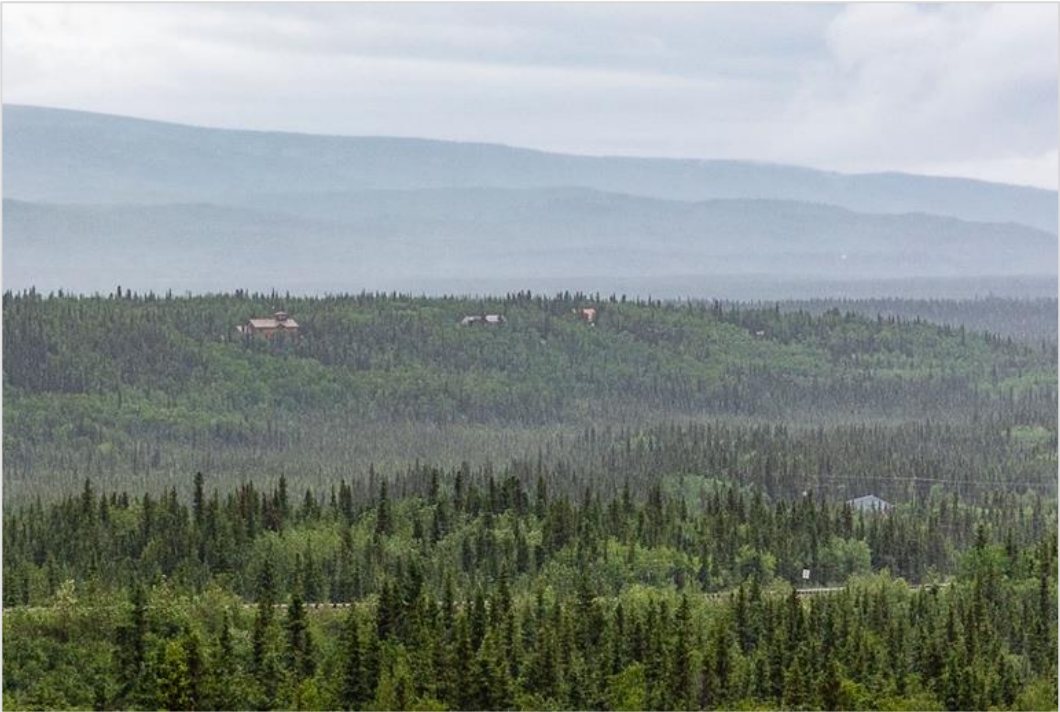
Figure 2 – Ridgetop

<b>Hazard Rating:</b>	<b>Very High</b>
<b>Utilities Above or Below Ground:</b>	Overhead power, heating oil and coal
<b>General Construction:</b>	Primarily wood siding with ignition resistant (IR) roof
<b>Dual Access Roads:</b>	No
<b>Road Widths, Slope and Surface:</b>	Steep, narrow dirt roads and driveways, some rough
<b>Water Supply:</b>	Dip/draft 2.1 to 3.8 miles, mean distance 3 miles
<b>Proximity to Fire Station:</b>	3.8 – 6.4 miles, mean distance 5 miles

Widely spaced homes on large lots. Mostly older construction, but there are a few newer homes. There are also some rental cabins in this Community. Wood siding or heavy timber with an asphalt or metal roof is the most common construction type. Flammable decks, stairs and projections are common, some properties have flammable outbuildings. Heating is supplied by electricity, wood stoves, fuel oil or coal and some homes have oil tanks or wood piles too close to structures. Most of the homes are built on ridgetops and mid-slope in steep, complex topography. Black and white spruce stands dominate the vegetation throughout and surrounding this Community. Some properties have partial defensible space clearings, but most have native vegetation too close to structures.

The topography rises steeply from the Parks highway with slopes of up to 30° and a mean slope of 8°, which makes this the steepest Community in the Healy AOI. The topography is complex with steep ridges and drainages. Elevations range from 1,299 feet to 1,932 feet. All the homes in Ridgetop are accessed from the Parks Highway by dead-end roads. These are generally rough, narrow dirt roads, surrounded by thick timber. There are tight hairpin turns that would be difficult for large suppression apparatus. Roads are marked at their intersection with the Parks Highway with reflective signage. There is only one other road intersection in this Community. Most houses don't have a visible address marker.

The only water for fire suppression is dip or draft from natural water sources or by tender shuttle from the Tri-Valley fire station in Central Healy. This is the nearest fire station to this Community and is between 3.8 and 6.4 miles away from the homes. The railroad runs to the east of this Community between the Parks Highway and the river.

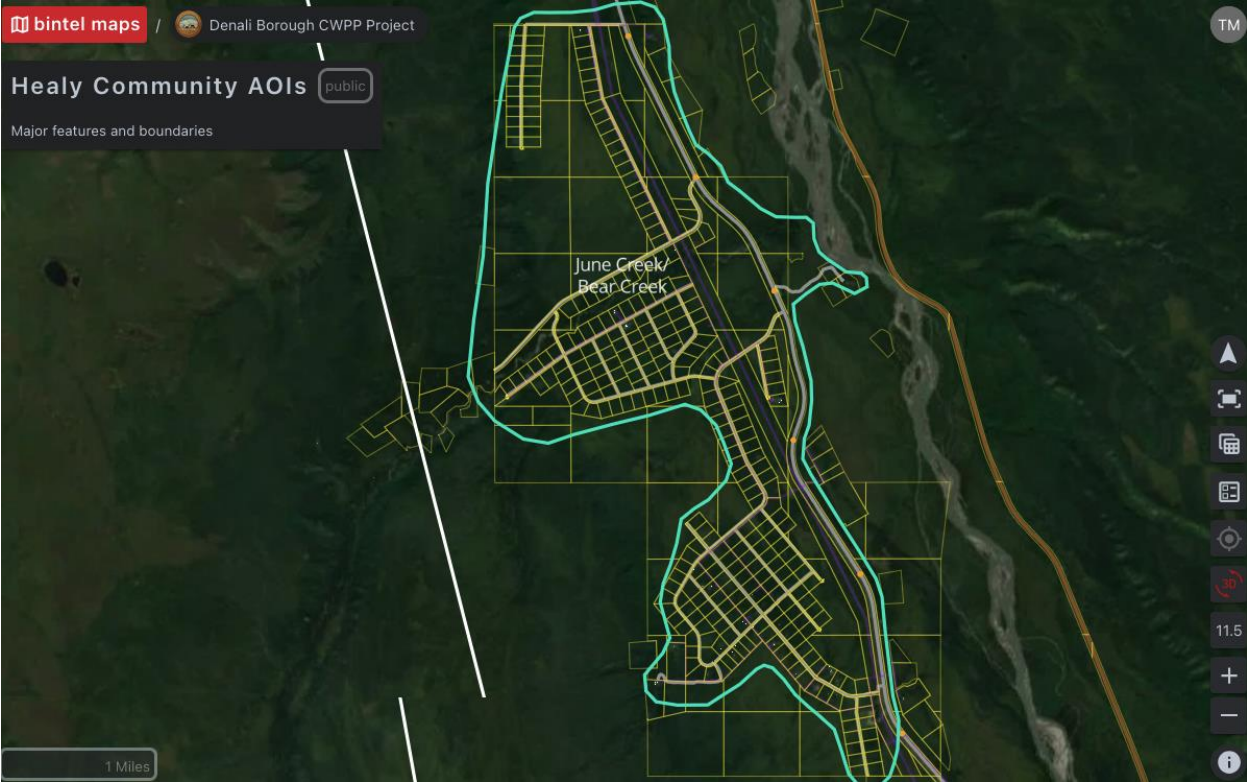
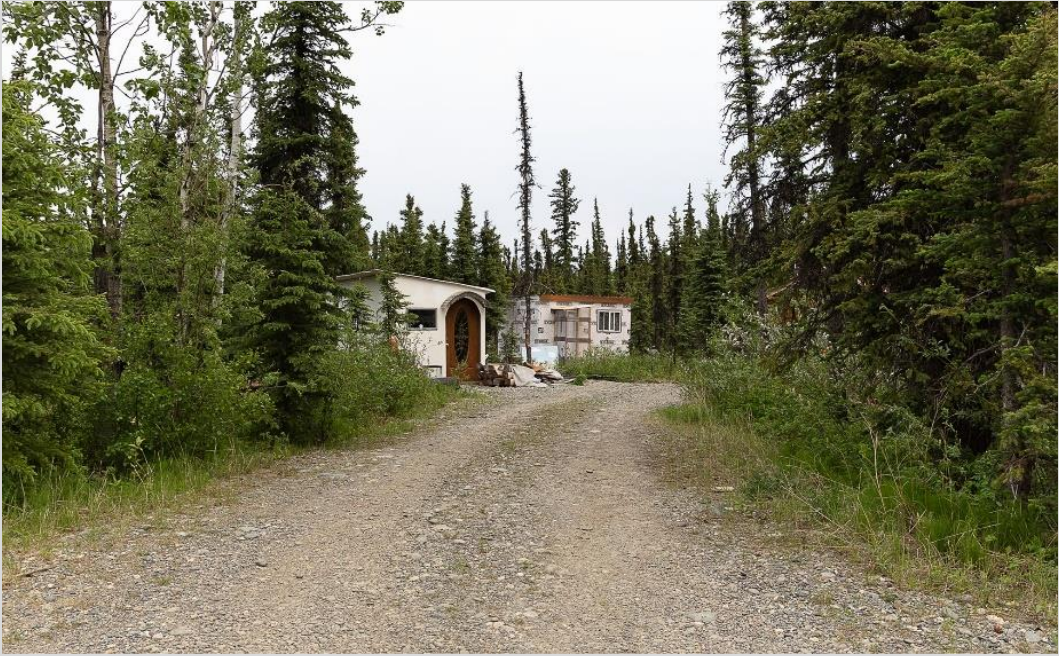
Figure 4 - June Creek/Bear Creek

<b>Hazard Rating:</b>	<b>Very High</b>
<b>Utilities Above or Below Ground:</b>	Overhead power, heating oil and propane tanks
<b>General Construction:</b>	Wood siding with mix of roof types
<b>Multiple Access Roads:</b>	Yes, but see text
<b>Road Widths, Slope and Surface:</b>	Flat dirt/gravel roads and driveways, most adequate width
<b>Water Supply:</b>	Dip/draft 1.1 to 3.8 mile, mean distance 2.5 miles
<b>Proximity to Fire Station:</b>	13.2– 17.5 miles, mean distance 15.5 miles

Bear Creek has approximately five homes located on both sides of Parks Hwy. Homes are primarily older construction. Almost all structures have wood siding with a mix of roof types including asphalt shingle, tar paper and metal. Some homes have flammable outbuildings and piles of flammable materials within 30 feet of homes. This includes wood piles, construction materials and other flammables. There are some abandoned structures and others in poor condition. Construction materials and styles are similar in June Creek. June Creek has two entrances from Parks Hwy., but the north and south entrances are not connected. Kennedy Road is not an entrance to the homes. It is a dead end that doesn't go through. There is a nightly rental complex (Sweet Seclusion) on the south side of June Creek and at least 13 other full-time residential properties. There are roads and several lots that have been platted but not built in this Community. Some homes do not have power and there are some dry cabins. Other homes have overhead power lines and ag tanks for water. Heating is supplied by electricity, wood stoves, fuel oil or propane and some homes have oil/propane tanks or wood piles too close to structures. Very few homes have any defensible space. Vegetation varies from grass/shrub to white spruce stands. Aspen/birch also occurs in some areas.

Although this Community has some slopes of up to 28°, there are significant portions that are flat to low angle. The total area has a mean slope of only 3°. Elevations range from 804 feet to 1,305 feet. This community is accessed by very rough roads with variable markings. There are several narrow sections and roads/driveways overgrown by vegetation. A few homes are accessed by dead end roads or driveways. While most homes have more than one way in, access to all relies on the Parks Highway. Most houses don't have a visible address marker.

The only water for fire suppression is dip or draft from natural water sources or by tender shuttle from Tri-Valley FD in Healy. This is the nearest fire station to this Community, and it is between thirteen and seventeen miles away from the homes. The railroad line runs along the eastern side of this Community, but it is on the opposite side of the river.

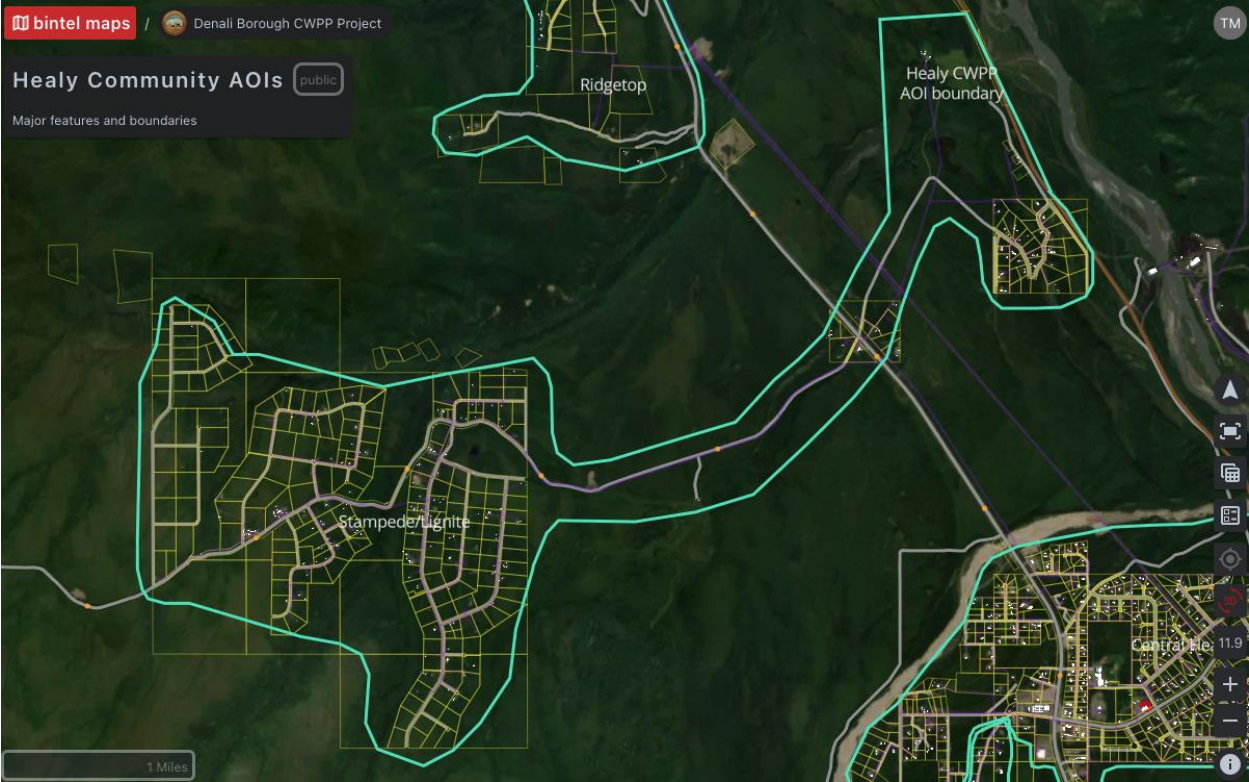
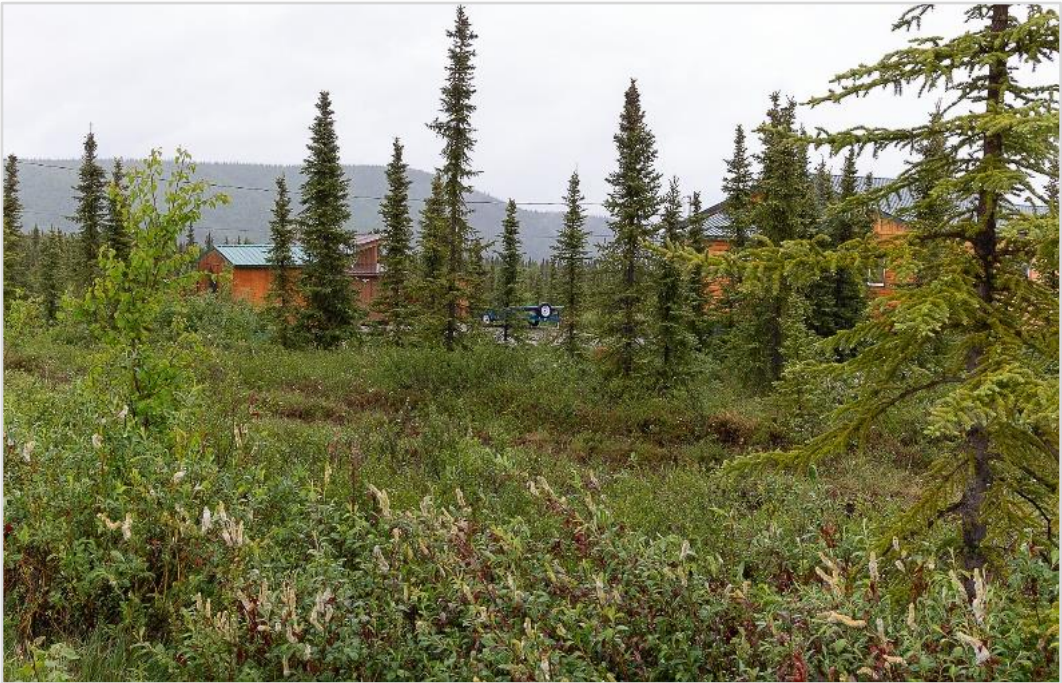
Figure 6 - Stampede/Lignite

<b>Hazard Rating:</b>	<b>High</b>
Utilities Above or Below Ground:	Overhead power, heating oil and propane tanks
General Construction:	Primarily combustibile siding with mixed roof types
Dual Access Roads:	No
Road Widths, Slope and Surface:	Paved and dirt roads. Some rough, narrow sections
Water Supply:	Dip/draft 0 to 4 miles, mean distance 2.4 miles
Proximity to Fire Station:	2.23 – 5.6 miles, mean distance 3.9 miles

Most of the homes in this Community are older wood siding construction, but there are some newer homes and homes are still being built. There are also permanently parked mobile homes that have been added on to. Flammable decks, stairs and/or projections are common features, and some properties have flammable outbuildings. There are many dry cabins in this Community. Electricity is supplied by overhead power lines. Heat is usually provided by coal or oil-fired boilers, but there may be some homes with propane tanks. Some homes have oil tanks, propane tanks, coal piles or wood piles too close to structures. Most of the existing homes have native vegetation too close to structures. Structure density is somewhat higher than other Communities in the Healy AOI, but homes are still widely spaced compared to Central Healy. Although there are significant timber stands near the homes, they are broken by more tundra-like vegetation. The Lignite Road area has hilly terrain that becomes steeper as you get further from the Parks Highway heading towards the Nenana River. Stampede Road climbs away from Parks Hwy. and most of these homes are significantly higher than the highway.

The steepest terrain is on the north side where some homes are located mid-slope and on ridges. Although slopes of up to 27° occur within this Community, there are significant areas near the Parks Hwy. and along Lignite Road that are flatter. The total area has a mean slope of 4.6°. Elevations range from 1,171 feet to 2,090 feet. Lignite Road is paved, but narrow and heavy vegetation grows right up to the asphalt in several sections. Other roads and driveways in this Community are dirt or gravel. There are several homes that can only be accessed by long dirt driveways with rough surfaces. Stampede road is tighter than Lignite but has a few good turnarounds. Street signs are generally good, but only some homes have address markers.

Although there is no municipal water or hydrant network in this Community, the Panguingue HOA has a communal well and there are dip/draft water sources. Water is also available by tender shuttle from Tri-Valley Fire. There is a grass landing strip for private planes in this Community. The coal tipple over the Nenana River on Industrial Way (AKA Tipple Road, east of the Stampede/Lignite Community) is considered critical infrastructure for the Usibelli Mine.

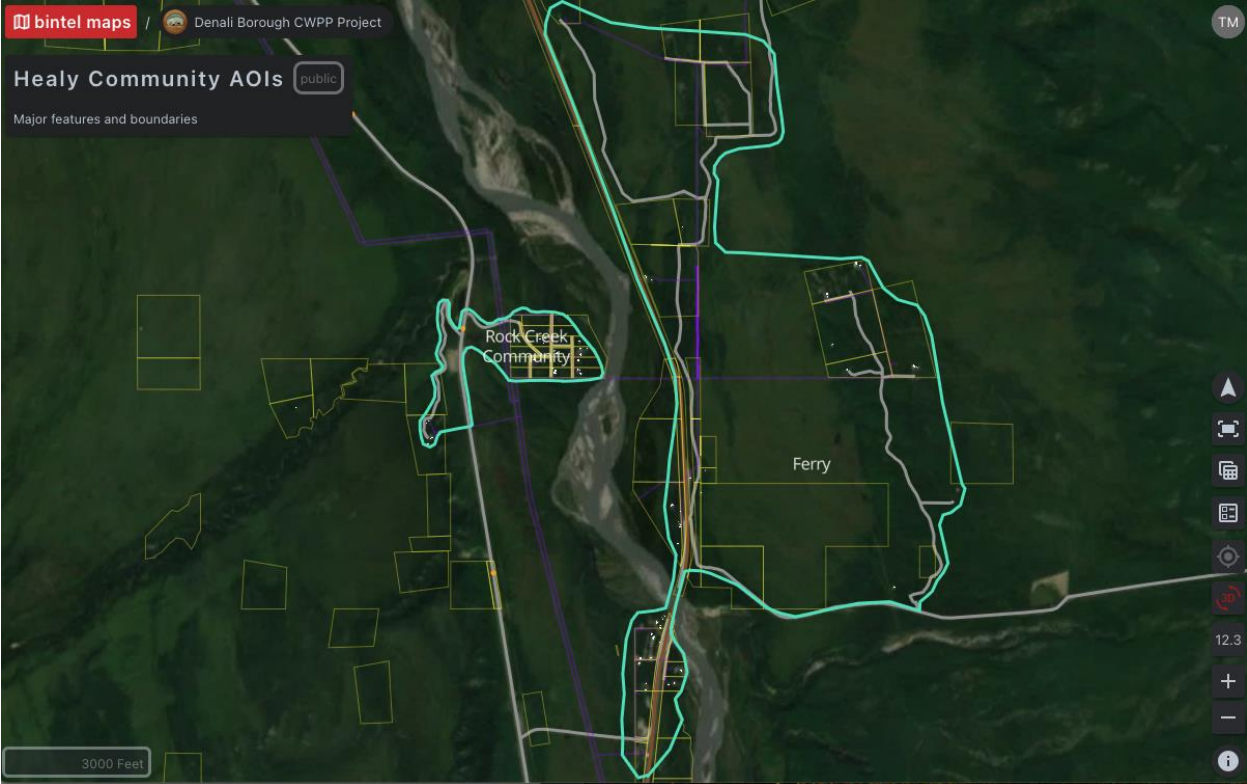
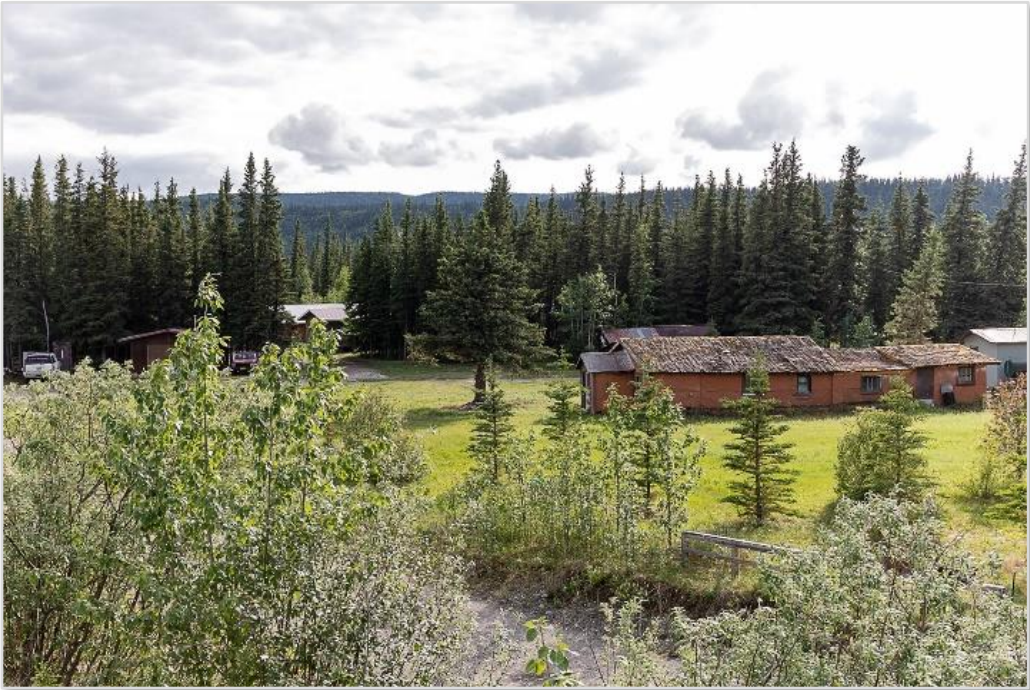
Figure 8 - Ferry

<b>Hazard Rating:</b>	<b>High</b>
<b>Utilities Above or Below Ground:</b>	Above ground power lines, fuel oil or propane tanks
<b>General Construction:</b>	Primarily flammable siding. Flammable roof types common
<b>Dual Access Roads:</b>	No
<b>Road Widths, Slope and Surface:</b>	Rough dirt access that is known to flood
<b>Water Supply:</b>	Dip/draft from the Nenana River, see text.
<b>Proximity to Fire Station:</b>	10 – 13 miles, mean distance 11.3 miles

Ferry has homes on both sides of the Nenana River. Homes are widely scattered north and east of the railroad bridge. Most of the homes are log or wood siding cabins with metal roofs, however some structures have flammable roof types such as wood shake shingles. Many properties have detached garages, sheds and/or other outbuildings. Most of these outbuildings are wood with a mix of roof types and very flammable. Some homes have piles of flammable materials in yards within 30 feet of structures. This includes wood piles, building materials and car parts. In addition to its flammability, this clutter could impede mitigation and suppression work. Few (if any) homes have any defensible space. There are dry cabins and some homes on the north side of the railroad bridge without power. Heating is supplied by electricity, fuel oil, coal or wood. Vegetation consists of heavy stands of white spruce and deciduous trees. There is only one way in and out and this dirt access road is narrow in some spots and has a rough driving surface. This road has also been known to flood. The railroad runs very close to homes in this Community and homes on the east side of the river can only be accessed by the railroad bridge. A narrow UTV (not a side-by-side) may be driven across, but not cars. Cars can only be driven across when the river is frozen. Some of the homes north and east of the railroad bridge are very remote and can only be reached by long, dirt dead-end roads and driveways.

Slopes in Ferry vary from flat up to 21° but the mean slope is only 2.6°. The area around most of the homes is flat to gently sloping. Elevations range from 968 feet to 1,273 feet. The only street sign is at the Ferry turnoff on Parks Hwy. Most homes do not have visible address markers. Those that do are inconsistent in type and placement and only a few homes have reflective address markers.

The closest water for fire suppression would be dip or draft from the Nenana River. The nearest fire department is Tri-Valley which is 10 to 13 miles from homes in this Community and fire apparatus cannot cross the railroad bridge to access the homes on the north side of Ferry.

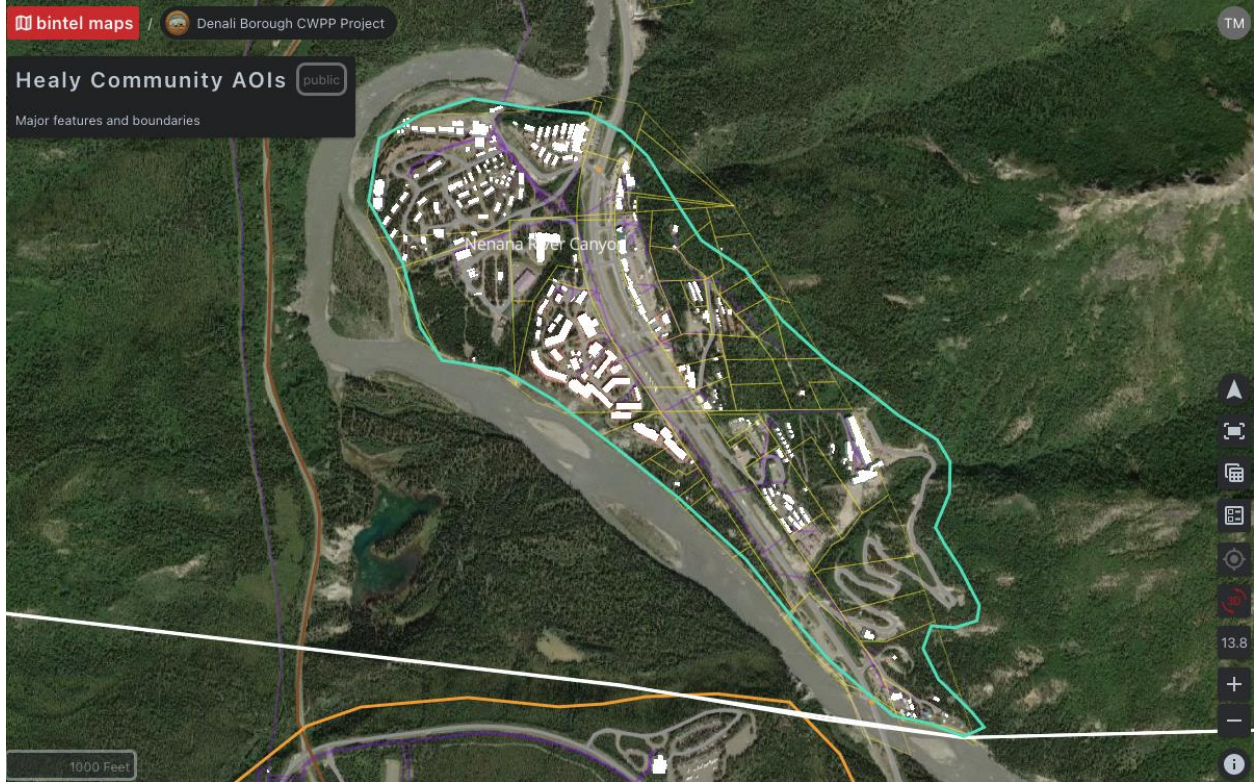
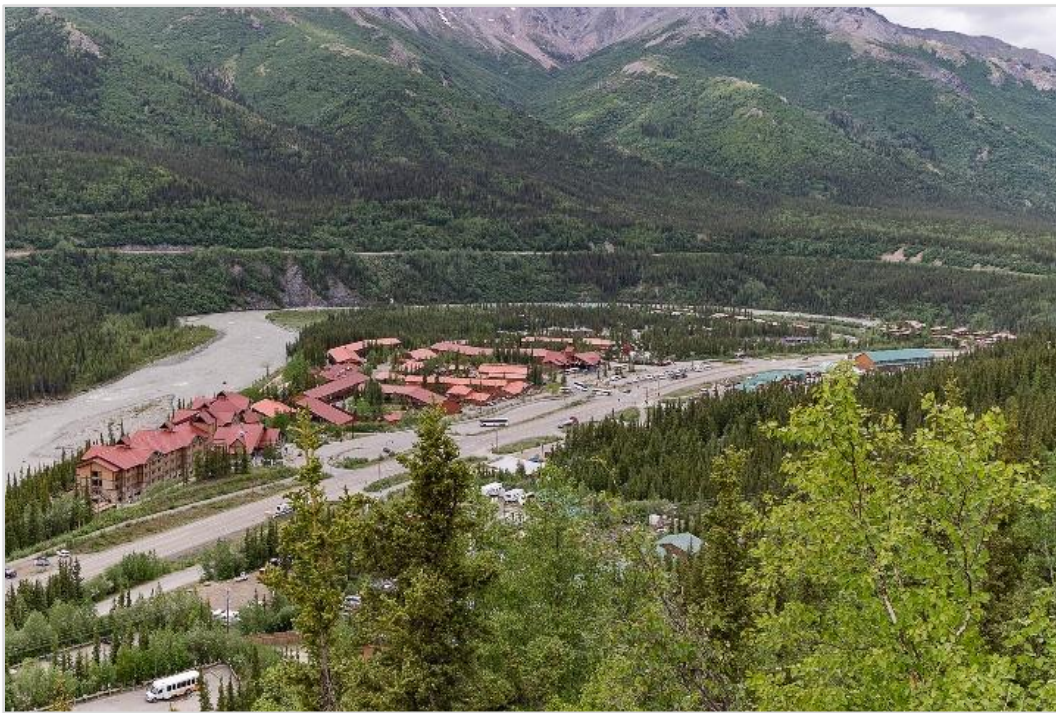
Figure 10 – Nenana River Canyon

<b>Hazard Rating:</b>	<b>High</b>
<b>Utilities Above or Below Ground:</b>	Above ground power lines, fuel oil or propane tanks
<b>General Construction:</b>	Primarily flammable siding with asphalt or metal roof
<b>Dual Access Roads:</b>	No
<b>Road Widths, Slope and Surface:</b>	Vary from paved multi-lane highway to steep dirt single lanes
<b>Water Supply:</b>	Dip/draft water available in this Community
<b>Proximity to Fire Station:</b>	6.4 – 7.5 miles, mean distance 7 miles

This is the primary commercial area for visitors to the Denali National Park. This area consists of seasonal lodges, retail shops, restaurants and businesses with some year-round employee housing. Dneali Princess Wilderness Lodge and the McKinley Chalet Resort are on the west side of Parks Hwy. and houses a large percentage of the overnight visitors that travel to Denali National Park. This area is a complex of resort-like hotels, lodges, event buildings and shops. There are also lodges on the east side of Parks Hwy., along with retail stores and restaurants. Housing areas have also been built into the hillside above the road. These are accessed by a very steep, narrow road with tight switchbacks. The Boardwalk is on the east side adjacent to Parks Hwy. This area is occupied residentially in the summer, mostly by employees of the stores and restaurants on the Boardwalk. There are no full-time residents in these buildings. Some of the larger employers in this ASI house seasonal and year-round residents on their properties.

There are dense spruce forests on both sides of the road. Nenana River Canyon has the steepest, most complex topography in the Healy AOI with slopes of up to 35° and a mean slope of 11.5°. Elevations range from 1,476 feet to 2,057 feet. The 2024 Riley fire burned in the east side of Denali National Park close to this Community.

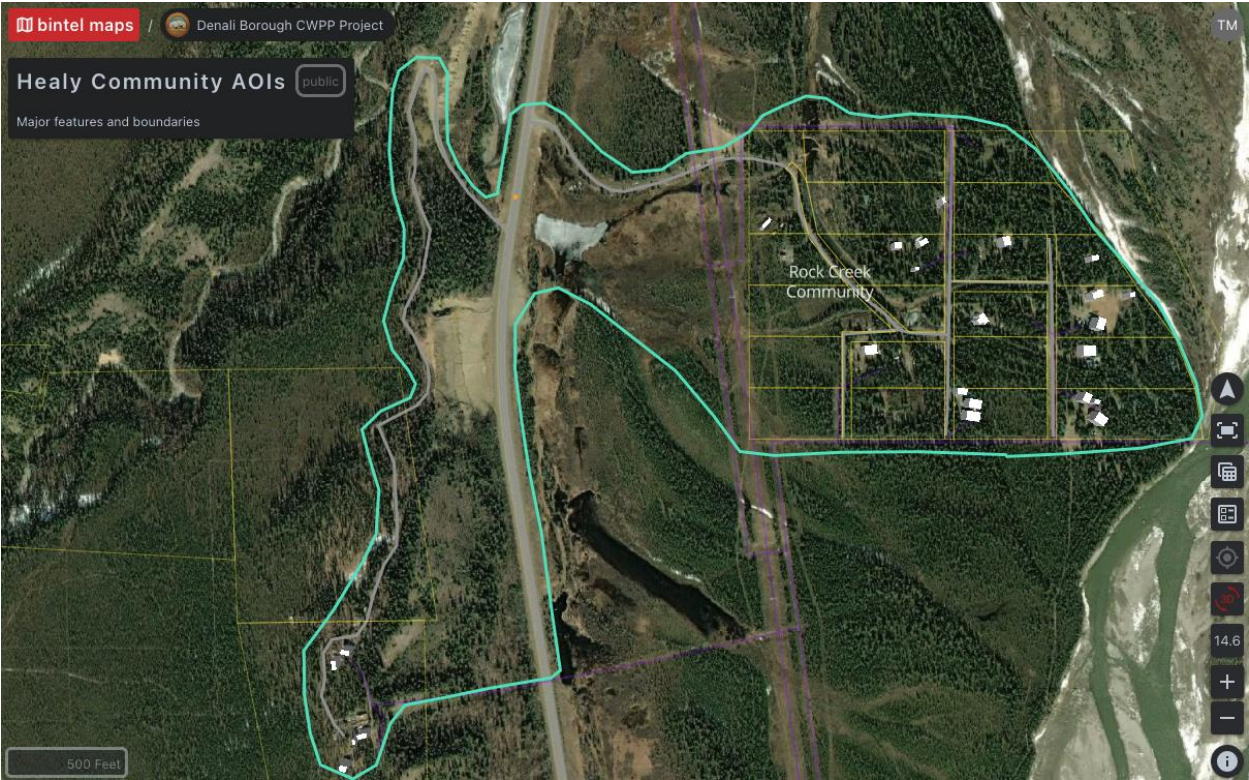
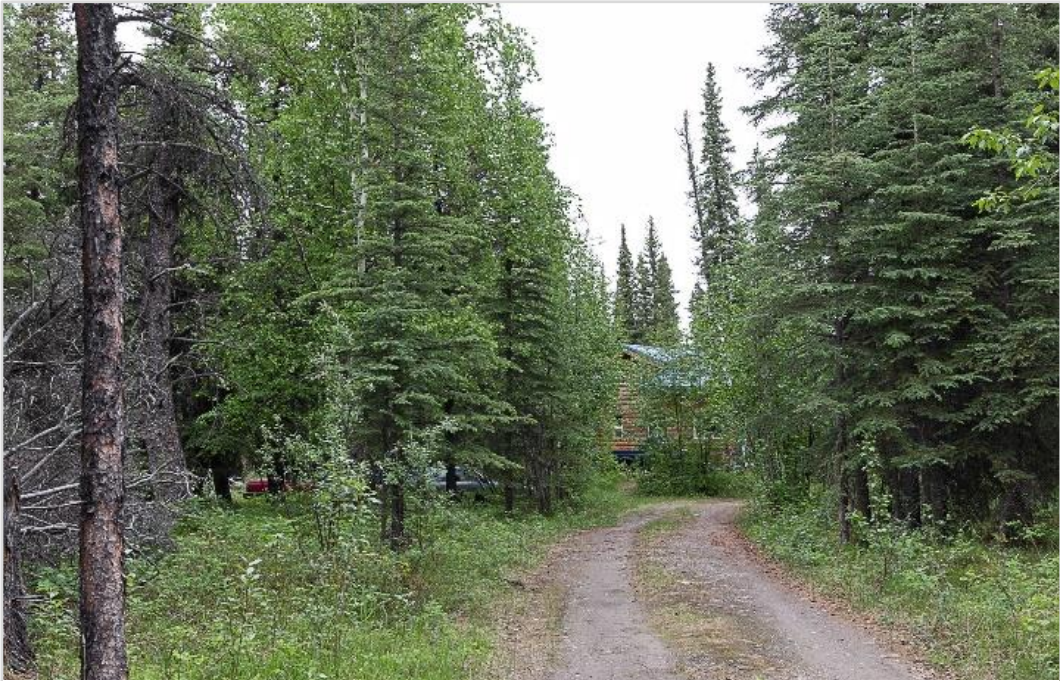
Figure 12 - Rock Creek Community

<b>Hazard Rating:</b>	<b>High</b>
<b>Utilities Above or Below Ground:</b>	Above ground power lines, fuel oil or propane tanks
<b>General Construction:</b>	Primarily flammable siding. Mostly metal or asphalt roofs
<b>Dual Access Roads:</b>	No
<b>Road Widths, Slope and Surface:</b>	Dirt access roads. Some sections rough, narrow and overgrown
<b>Water Supply:</b>	Dip/draft water in this Community.
<b>Proximity to Fire Station:</b>	11.4 – 11.8 miles

Most of the homes are heavy timber or wood siding cabins with metal roofs. Many properties have detached garages, sheds and/or other outbuildings. Most of these outbuildings are wood siding with a mix of roof types. Although some homes have clearances, most are too close to native vegetation, and few have any defensible space. There are overhead powerlines, and heating is supplied by electricity, fuel oil, coal or wood. Vegetation is generally thick stands of white spruce, but aspen/birch also occur. There are a few grassy areas and there is a rock quarry on the west side of Parks Hwy. There is only one way in and out and on each side of Parks Hwy. All the roads are dead-ends, and there are many sections with heavy vegetation growing right up to the driving surface. Most of the access roads and driveways are rough and narrow. Some are unmaintained two-tracks. There are few pullouts or turnarounds for apparatus.

The topography in Rock Creek is steep and complex with slopes up to 32°, however most of the homes east of Parks Hwy. are in flat or gently sloping terrain. Homes on the west side of Parks Hwy. are built at the top of steep slopes. The mean slope in this Community is 6.6°. Elevations range from 981 feet to 1,316 feet. Street signs are present on both sides of Parks Hwy, but some interior intersections are not marked. Most homes do not have visible address markers.

The closest water for fire suppression would be dip or draft from ponds in and near this Community. The nearest fire department is Tri-Valley which is 11 to 12 miles from homes in Rock Creek. The railroad line runs along the eastern side of this Community, but it is on the opposite side of the river.

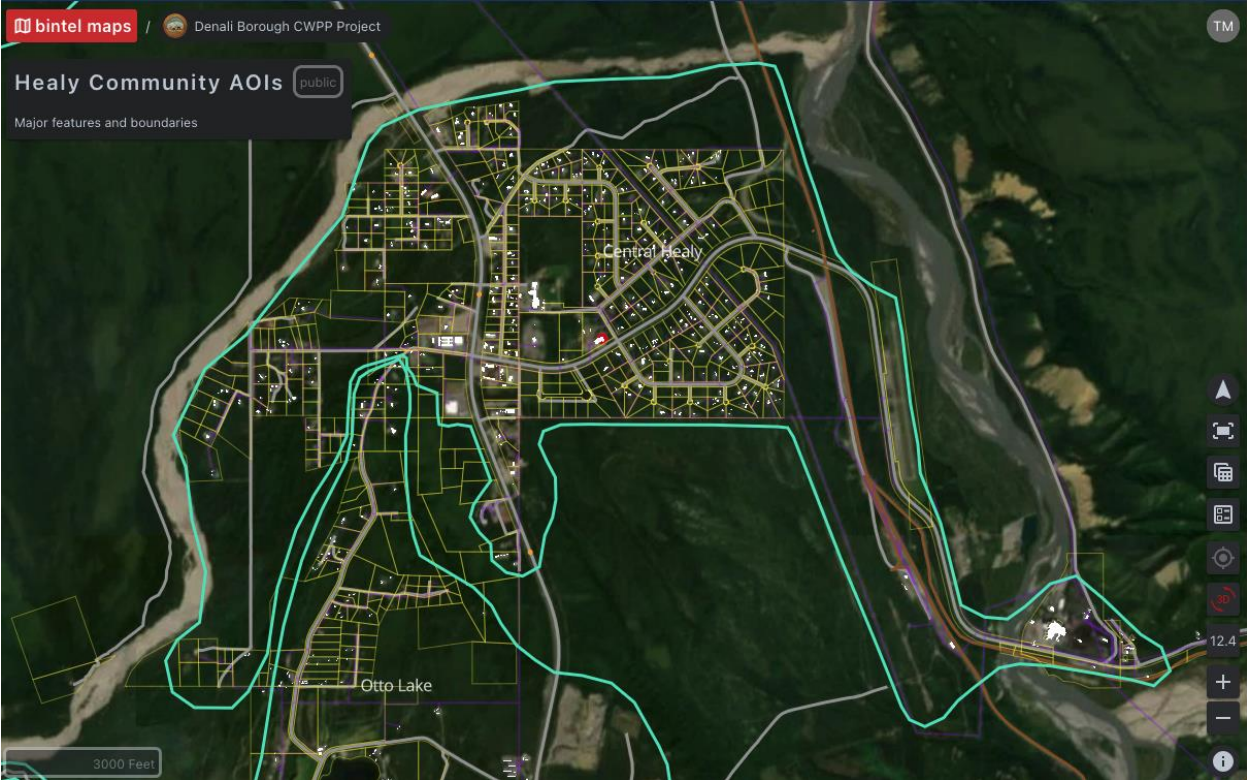
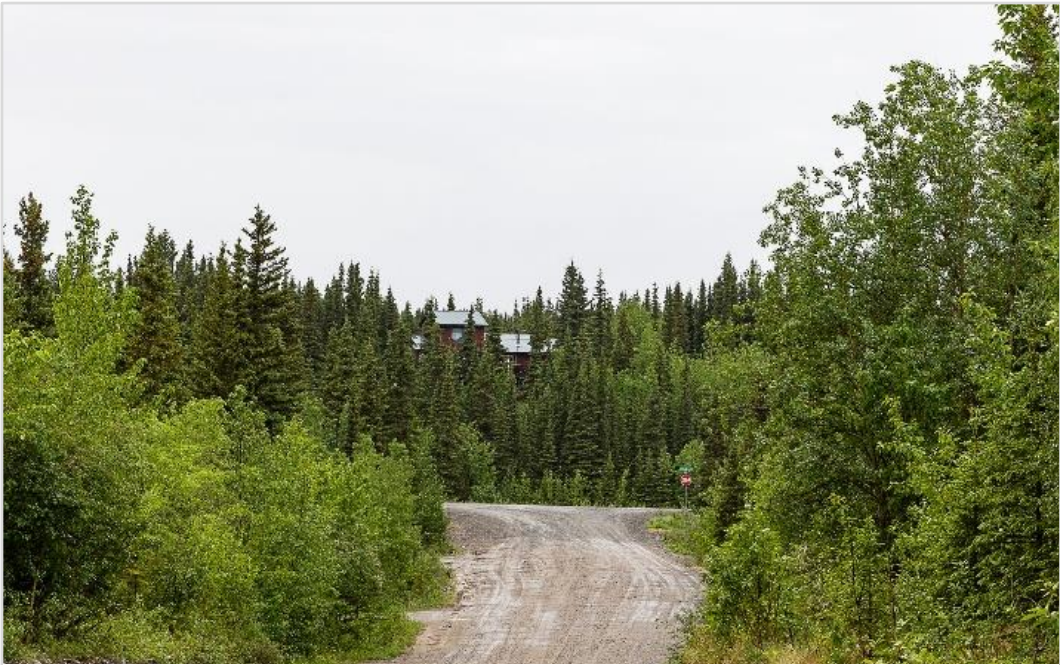
Figure 14 - Central Healy

<b>Hazard Rating:</b>	<b>Moderate</b>
Utilities Above or Below Ground:	Above ground power lines, fuel oil or propane tanks
General Construction:	Primarily flammable siding. Mostly metal or asphalt roofs
Dual Access Roads:	Yes, but all rely on Parks Highway
Road Widths, Slope and Surface:	Mix of paved, gravel and dirt access roads
Water Supply:	Water supply at FD station
Proximity to Fire Station:	Station in this Community. Mean distance to homes 1 mile
Hazard Rating:	Moderate

The central area of Healy has the highest density of residential development in the AOI and consists of restaurants, businesses, schools and commercial development areas mixed in with seasonal and year-round residences. Most of the seasonal employee housing for Holland America-Princess is in this Community and during the summer this causes a significant increase in the population. Lot sizes tend to be small and homes close together especially close to Parks Hwy. Homes in Central Healy have been built on both sides of Parks Hwy. with mixed construction types. Most homes have wood siding or log construction with metal or asphalt roofs. Many properties have detached garages, sheds and/or other outbuildings. Most of these outbuildings are wood siding with a mix of roof types. Although there are large clearances in the central core most of the homes are too close to native vegetation, and only some have any defensible space. There are overhead powerlines, and heating is supplied by electricity, fuel oil, coal or wood. Vegetation is generally thick stands of white spruce, but aspen/birch also occur. There are multiple ways in and out of Central Healy, but all of them rely on Parks Hwy. Many homes are accessed by dead-end roads or long driveways. Many of these do not have pullouts or turnarounds for apparatus.

Although there are slopes up to 30° and some homes built mid-slope or at the top of rises, most of the homes are in flat or gently sloping terrain. The mean slope in this Community is only 2.9°. Elevations range from 1,234 feet to 1,781 feet. Street signs are present and reflective at most intersections. Some homes have reflective address markers visible from the street, but many others do not. Tri-Valley maintains water tanks and a water tender for fire suppression.

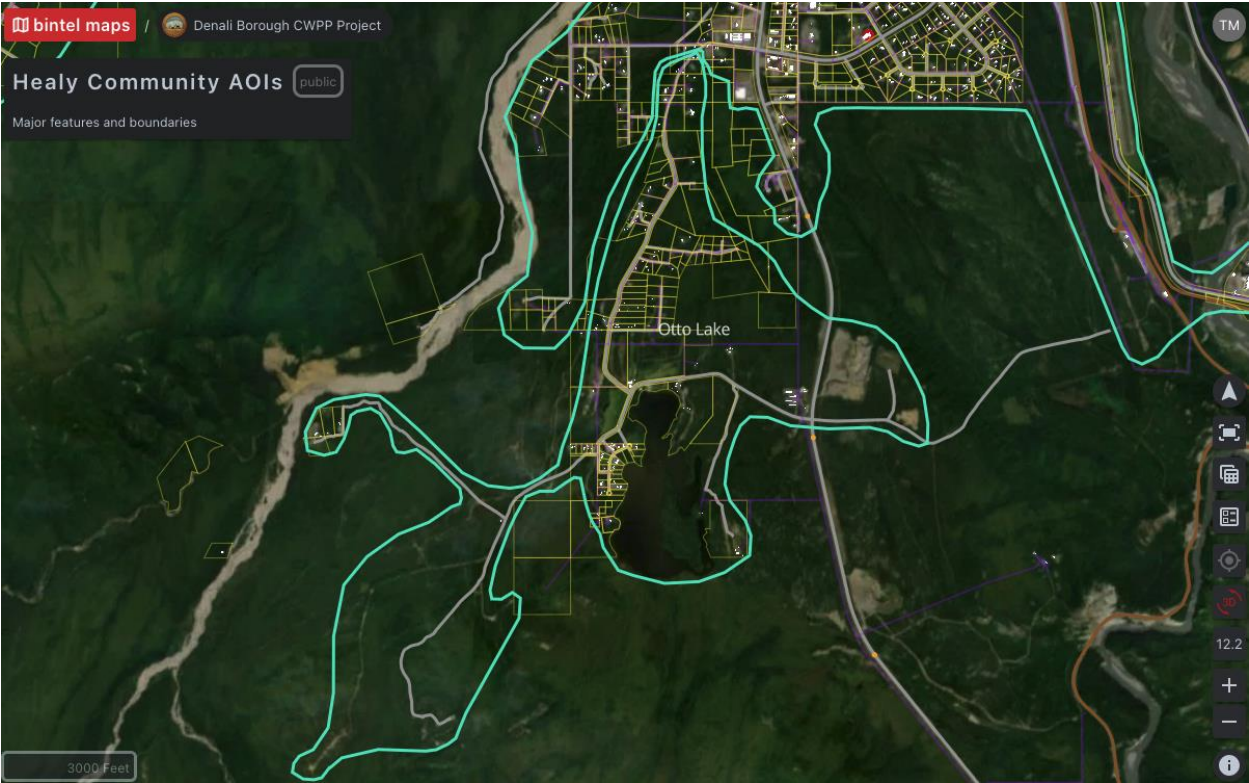
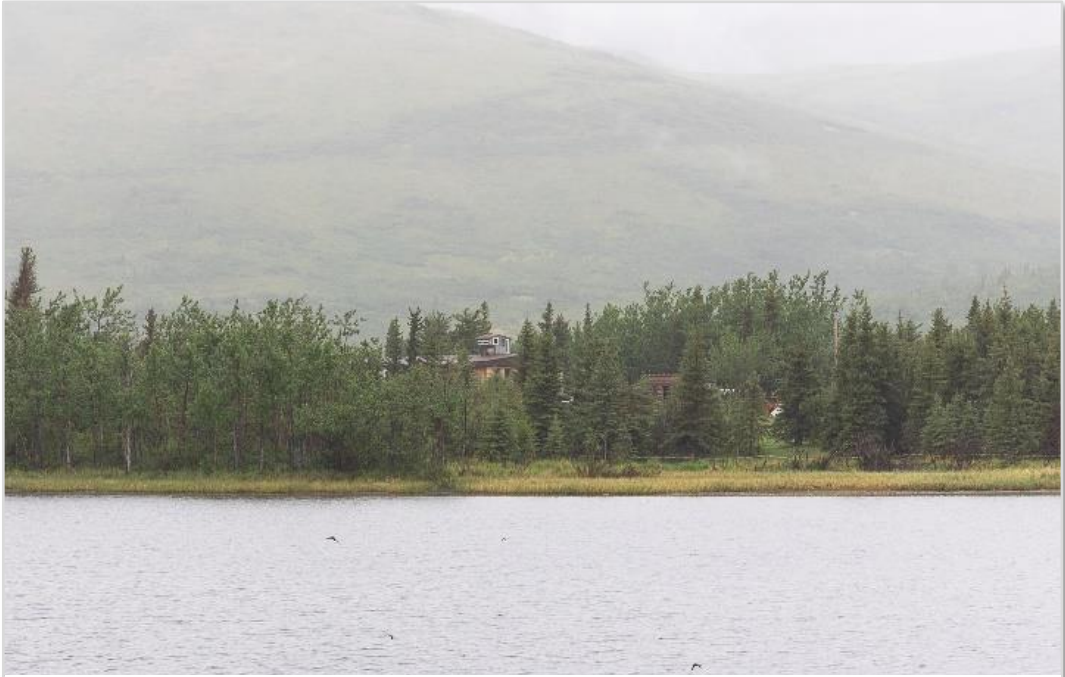
Figure 16 - Otto Lake

<b>Hazard Rating:</b>	<b>Moderate</b>
Utilities Above or Below Ground:	Above ground power lines, fuel oil or propane tanks
General Construction:	Primarily flammable siding. Mostly metal or asphalt roofs
Dual Access Roads:	Yes, but see text
Road Widths, Slope and Surface:	Some dirt access roads with rough surfaces
Water Supply:	Dip/draft water in this Community.
Proximity to Fire Station:	0.8 miles to 3.6 miles. Mean distance < 2 miles

Otto Lake is the most southern development in the Healy AOI. The homes immediately around the lake are widely spaced on hilly terrain. There are some horse properties and some homes with paved driveways. Most of the homes are heavy timber or wood siding construction with metal roofs. Several have flammable decks, stairs or other projections. Many properties have detached garages, sheds and/or other outbuildings. Most of these outbuildings are wood siding with a mix of roof types. Many of the homes around the lake have some clearances but most are still too close to native vegetation. Most homes are surrounded by native fuels and away from the lake, few have any defensible space. There are overhead powerlines, and heating is supplied by electricity, fuel oil, coal or wood. This area has a nearly continuous fuelbed of mixed spruce and deciduous forest broken only by some large industrial clearings and grassy meadows north of the lake. There are multiple ways in and out of this Community, but they all rely on the Parks Hwy. Some of the homes are located on dead-end roads and driveways with heavy vegetation growing right up to the driving surface in some areas. Most of these, however, have at least some pullouts or turnarounds for apparatus. Away from the lake there are one or two homes on Pioneer Road and two more on Boghole Road. Both roads are rough dirt with poor surfaces, but all these homes have some clearance to the forest and at least partial defensible space.

Away from the lakeshore the topography remains hilly with slopes up to 20°. The mean slope in this Community is 3.8°. Elevations range from 1,522 feet to 2,448 feet. Street signs are present, but some of the remote intersections in the southern part of this Community may not be marked. Many homes do not have visible address markers.

The closest water for fire suppression would be dip or draft from Otto Lake. The nearest fire department is Tri-Valley which is 0.8 to 3.6 miles from homes in Otto Lake.
